**CASE STUDY: PROPOSED 70 BED MOTHER KEVIN WING AT
ST. FRANCIS HOSPITAL NSAMBYA, KAMPALA UGANDA**

**BY
KUTOSI, J. BSC (CIVIL ENGINEERING) (Mak)**

**A REPORT SUBMITTED TO THE
GRADUATE SCHOOL IN PARTIAL
FULFILMENT FOR THE AWARD OF
POST GRADUATE DIPLOMA DEGREE OF
MAKERERE UNIVERSITY**

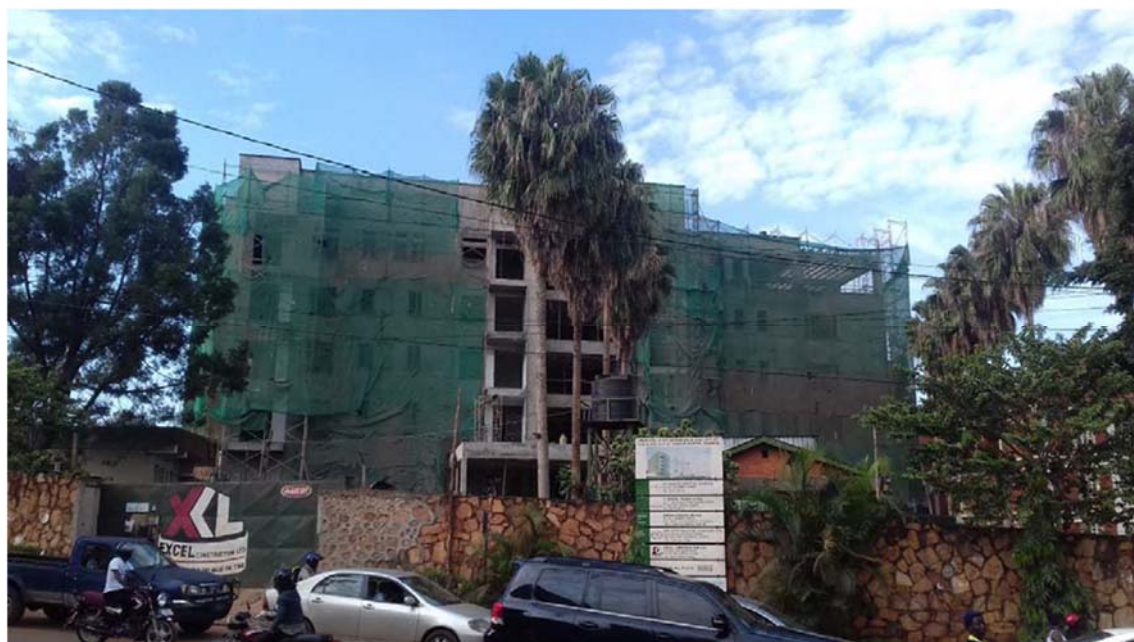
Figure 5: Site Progress in elevation

Achieved progress of site is about 63% and value of work certified is about 45%. Project period elapsed is 82.4% as of December 2021.

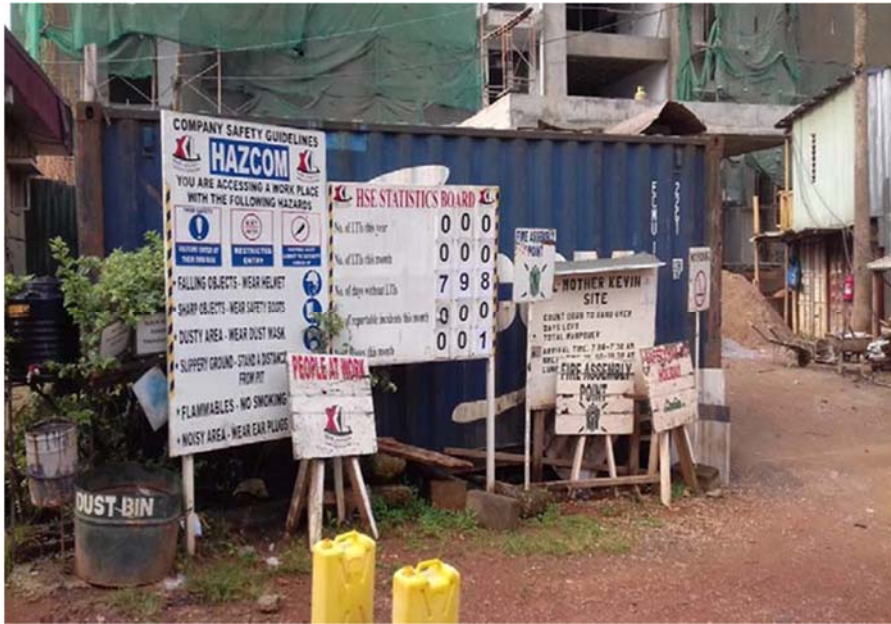
Figure 6: Site Safety guidelines and statistics

- Fire prevention, fire extinguishers were basic requirements on a construction project. The site had a variety of firefighting equipment including 8 fire extinguishers, 2 fire blankets, etc.
- Medical services: a first aid kit was necessary. In remote projects, a well-equipped medical room with a doctor and nurse is important. The site had two well-trained safety officers with first aid treatment training.
- Construction safety clothing. The site had a variety of Personal Protective equipment for all its workers and staff. A strict Health and Safety Policy back this.

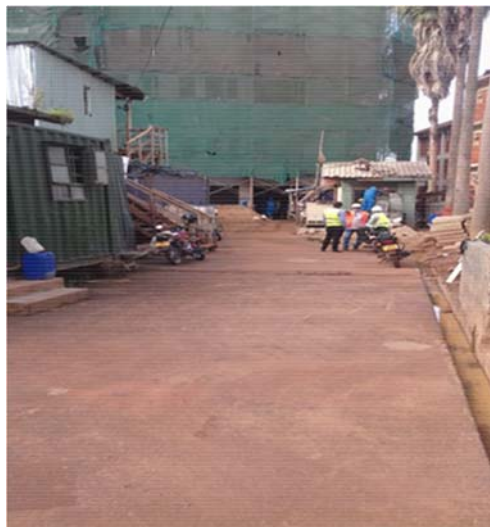
Figure 7: Site Access route for pedestrians and trucks

As seen in Figure 7 below, the access for vehicles and trucks ferrying materials is adequate. This is plausible. This access can also be seen on the site layout drawing.

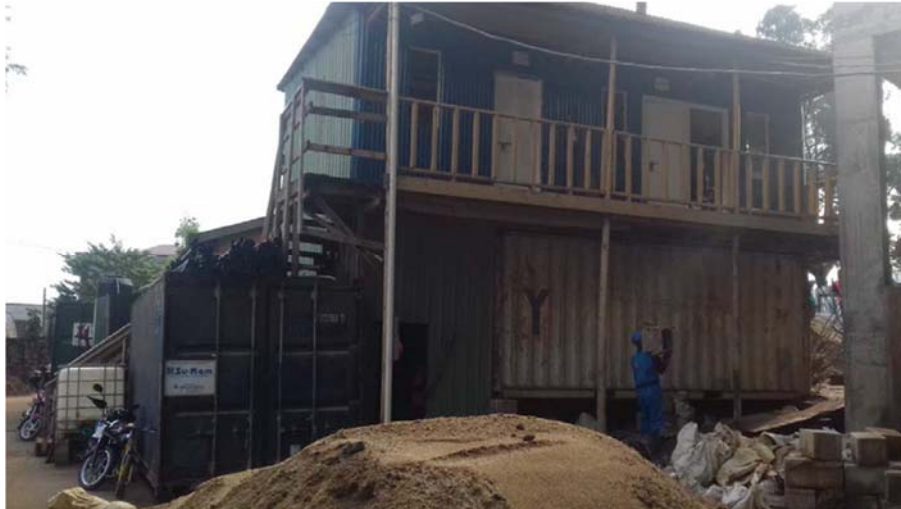
Figure 9: Site Offices

The site has convenient site offices and proper office equipment as seen on the site layout drawing. This is commendable.

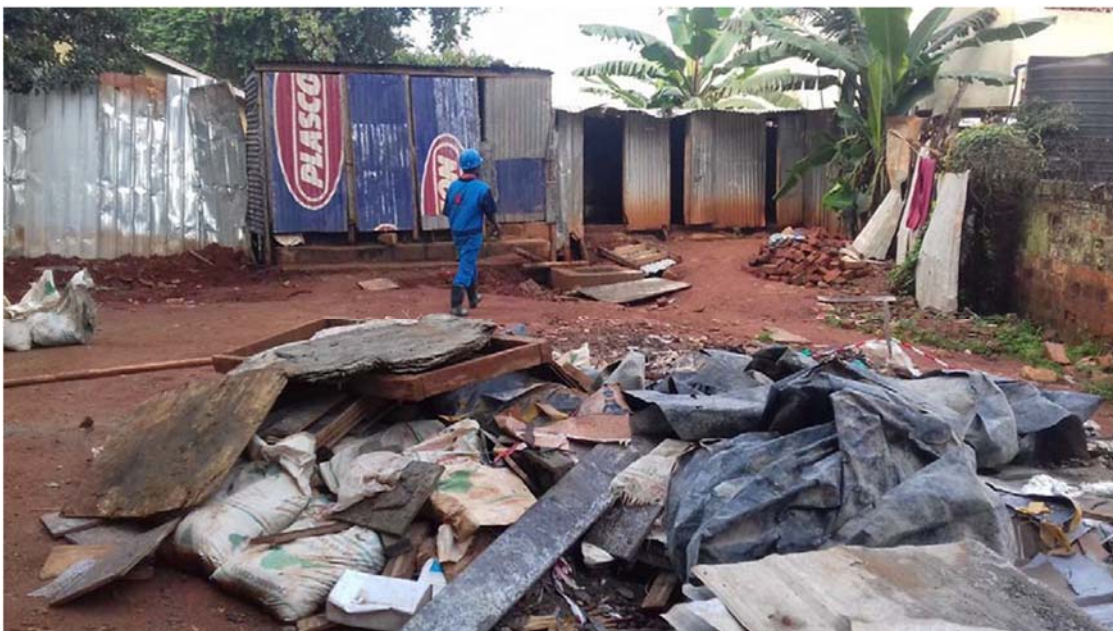
Figure 10: Toilet Facilities

The site had several toilet and shower facilities. It also had water supply points for both drinking water and tap water. These can be seen on the Site Layout drawing.

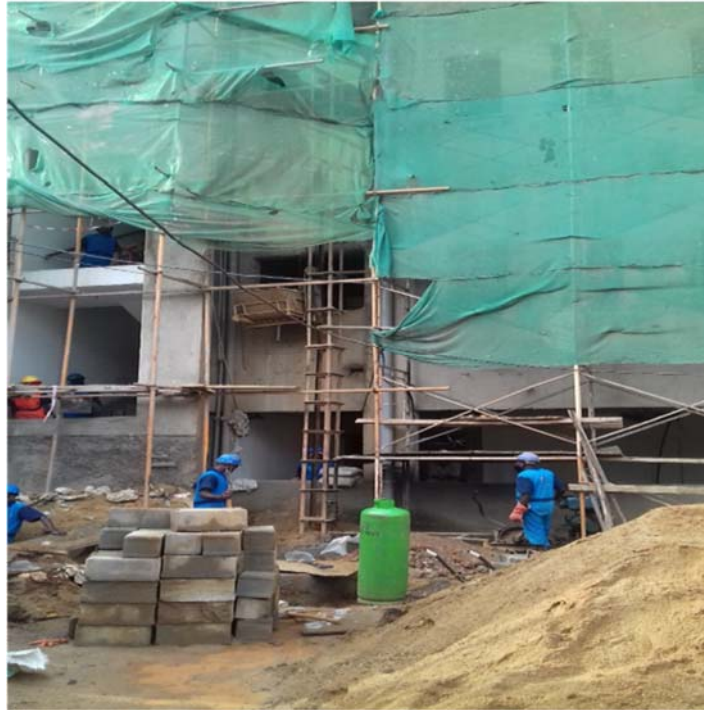
Figure 11: Material and Hoist Machine

The site had a hoist machine and material stock placed close by to reduce the chances of multiple handling.

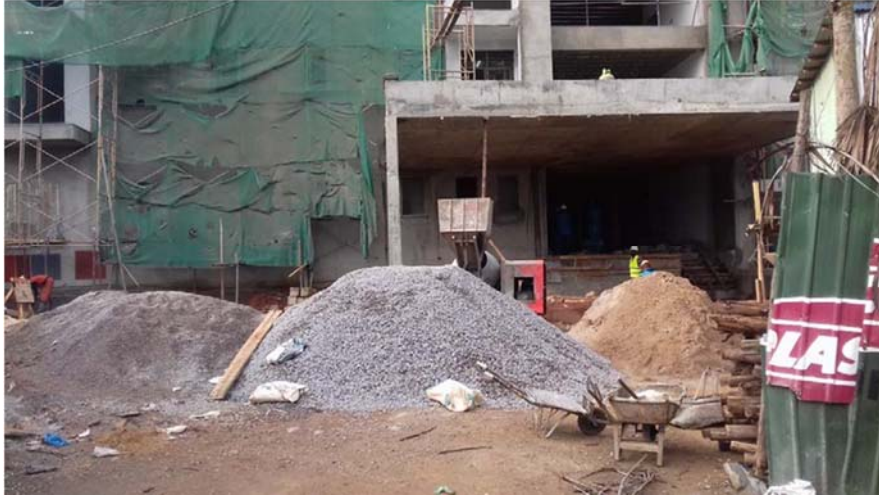
Figure 12: Concrete batch plant at site. In view is a small mixer machine

Batch plants are provided on projects where it is more economical to produce concrete on site. Aggregate storage piles, cement silos and admixture tanks will accompany an on-site batch plant.

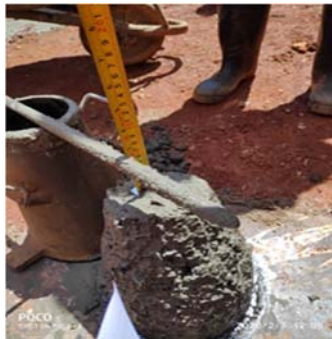
Figure 13: Slump test for concrete

There were several quality control measures in place for the works which included testing of materials for example steel, concrete and blocks. This was generally done following ASTM.

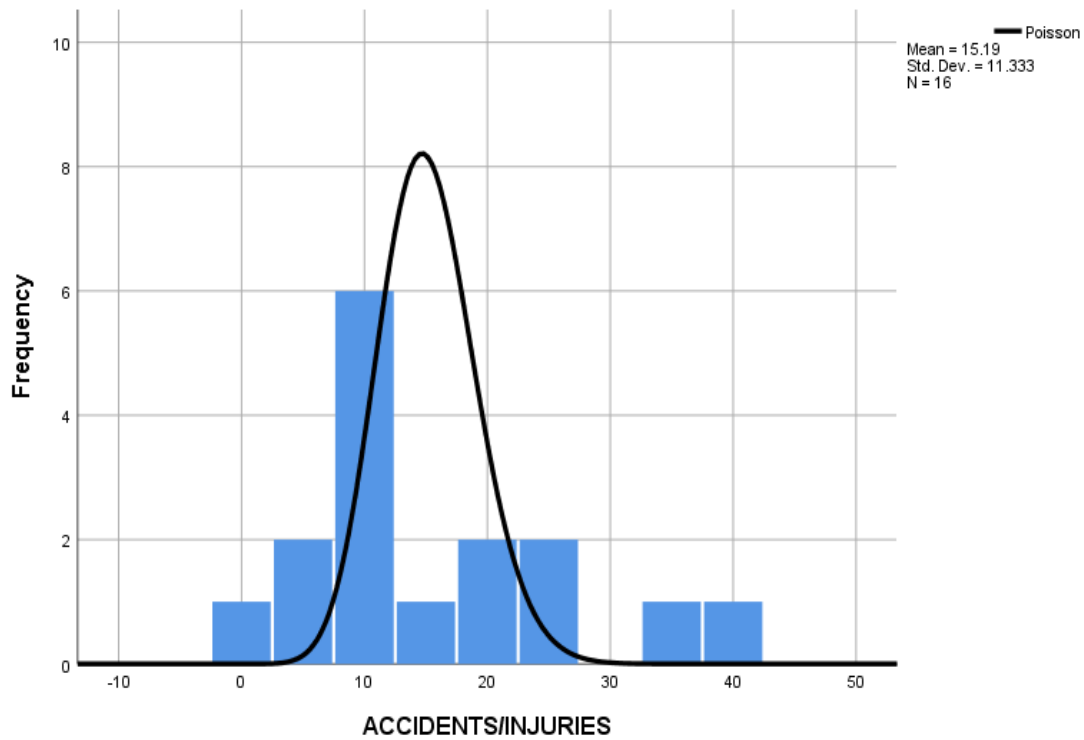
Figure 14: Poisson distribution graph of results from analysis above

Mean	15.19
Median	10.50
Mode	8
Range	42
Minimum	0
Maximum	42

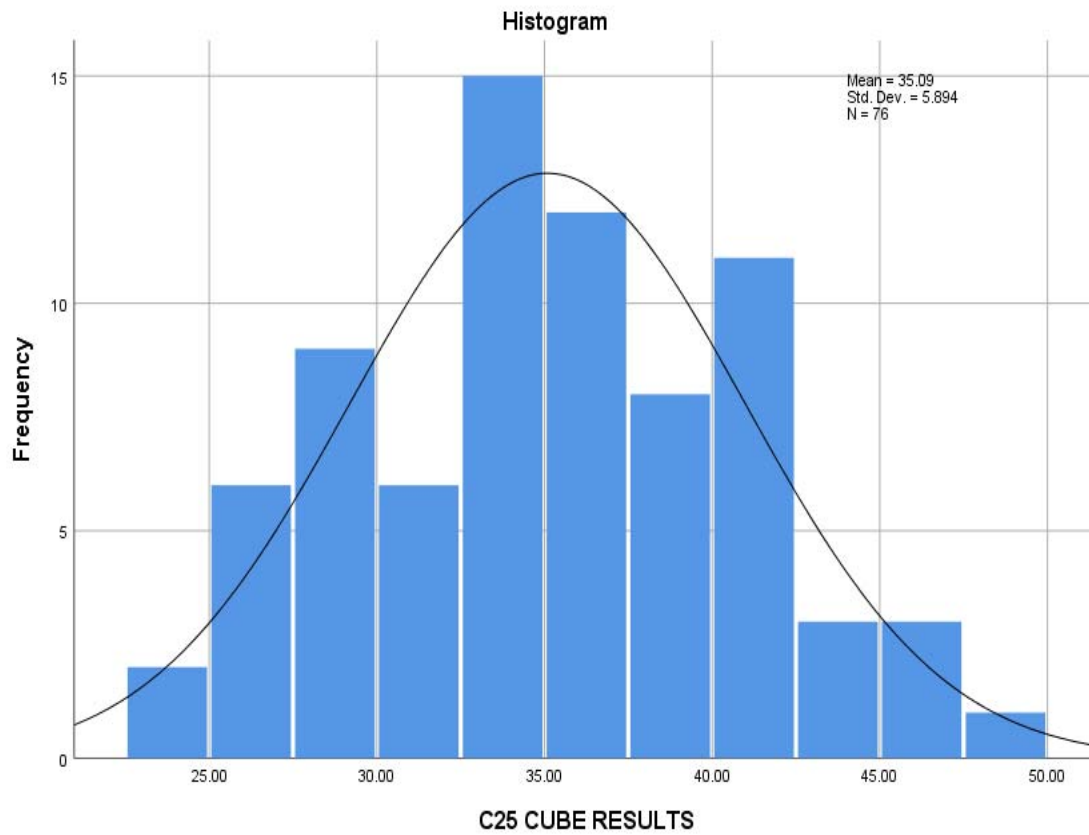
Figure 15: Figure showing binomial distribution for results above.

Statistic	Std. Error
C25 CUBE RESULTS	Mean	35.0876	0.67612
	Median	34.7500	
	Variance	34.742	
	Std. Deviation	5.89426	
	Minimum	23.50	
	Maximum	49.00	
	Range	25.50	
	Interquartile Range	8.73	
	Skewness	0.083	0.276
	Kurtosis	-0.637	0.545
